CALSPAN ON-SITE AIR BAG DEPLOYMENT INVESTIGATION

CALSPAN CASE NO. 94-23

VEHICLE #1 - 1993 CHEVROLET CORSICA LT (AIR BAG-EQUIPPED) VEHICLE #2 - 1986 CHEVROLET CELEBRITY STATION WAGON

On-site investigation of an air bag deployment crash that resulted in the separation of the air bag module from the steering wheel during the air bag deployment sequence. The driver received burns from the air bag exhaust generant.

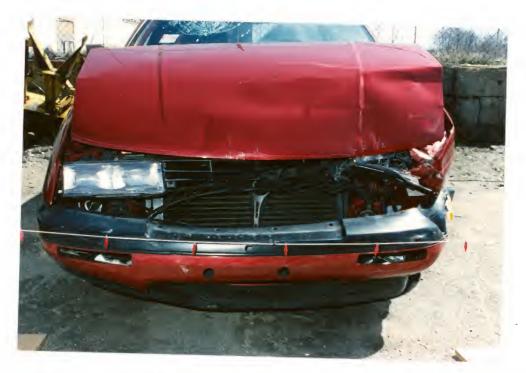
15. Frontal view of the 1993 Chevrolet Corsica LT (Vehicle #1) showing the entire contacted plane.

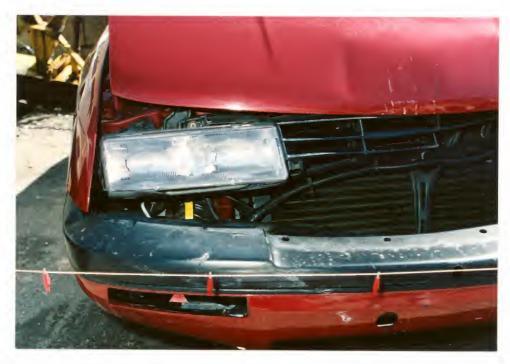
16. Frontal view of Vehicle #1 showing contact along the right side of the frontal plane.

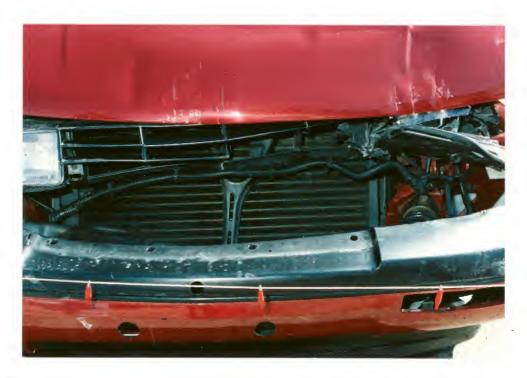
17. Frontal view of Vehicle #1 showing contact along the center of the frontal plane.

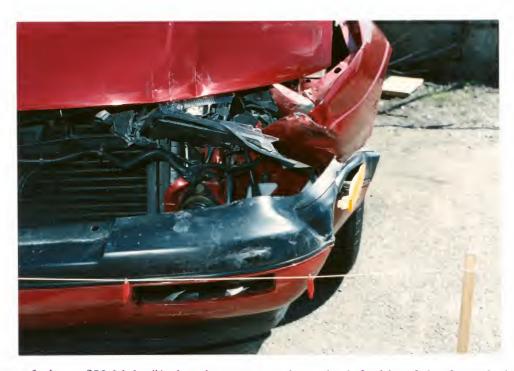
18. Frontal view of Vehicle #1 showing contact along the left side of the frontal plane.

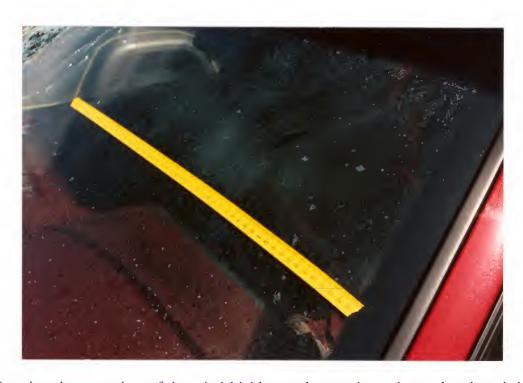
20. Exterior close-up view of the windshield over the steering column showing air bag generant debris.

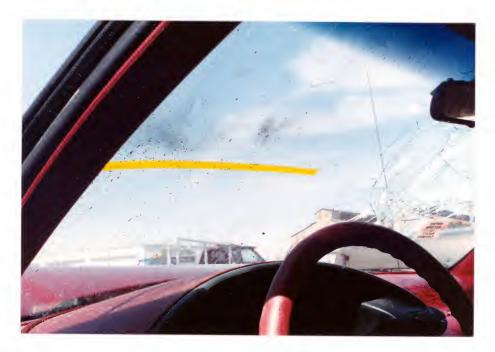
21. Interior view of the windshield showing the heavy concentration of generant debris above the air bag module.

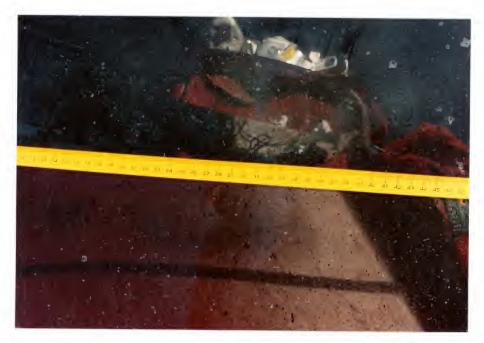
22. Overhead view of the windshield showing the heavy concentration of generant debris in relationship with the air bag module.

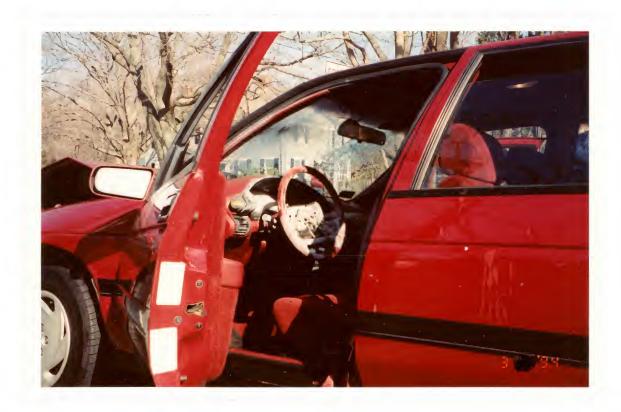
31. On-scene view of the steering wheel showing the separation of the air bag module from the steering wheel hub and a heavy generant residue.

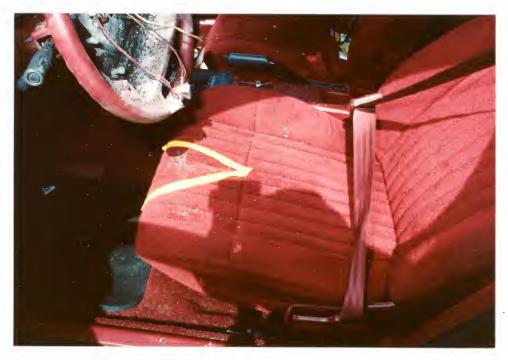
A "V" shaped pattern in the center of the driver's seat cushion along the leading edge of the seat and measuring 10.1 cm (4.1") laterally and 17.8 cm (7.0") longitudinally contained a concentration of BB size burn marks from discharged inflator generant. The floor mat just beneath the steering wheel exhibited a 1.9 cm (0.8") burn mark where the fibers were melted by generant pellets which dropped down from the steering wheel hub (refer to photographs #33, #35, #36 on pages A-17, A-18).

The driver's seat cushion exhibited a "V" shaped burn mark pattern which measured 10.2 cm (4.0") along the front edge of the cushion and extended rearward 17.8 cm (7.0"). This pattern occurred as air bag propellent dropped from the steering wheel area during the module separation and reflected the presence of the driver's legs which prevented a wider distribution of propellent debris on the seat cushion.

33. Lateral view of the driver's seat cushion highlighting a "V" shaped area on the seat fabric which was singed by air bag generant debris.

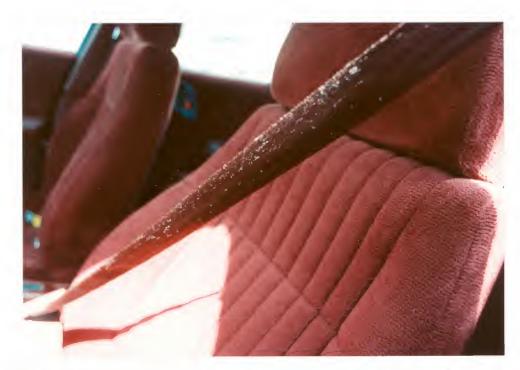
34. View of the driver's torso belt showing air bag generant debris embedded in the weave of the belt

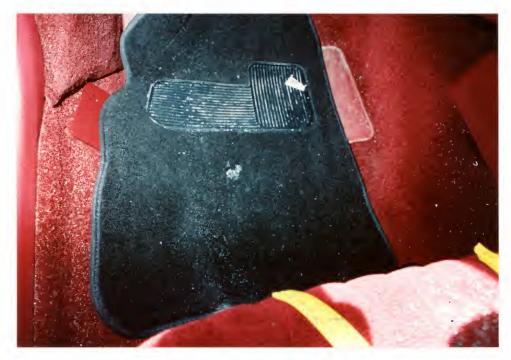
A 2.5 cm (1.0") diameter burn mark was noted on the driver's side floor mat directly below the steering wheel. This burn mark was the result of air bag propellent debris which fell from the recessed area in the steering wheel hub.

35. View of the driver side floor mat which was singed by air bag generant debris. This area was located directly under the steering column.

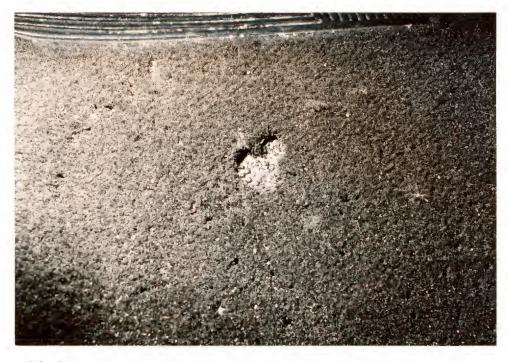
36. Close-up view of the singed mark on the driver side floor mat.

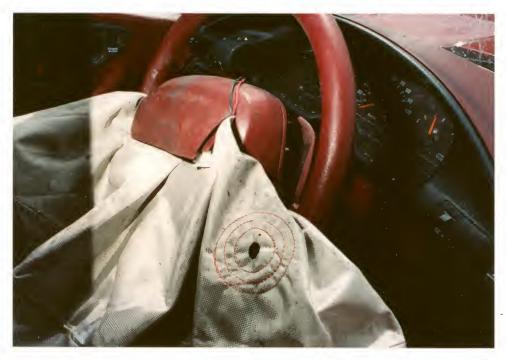
41. View from the right side of the steering wheel with the air bag module repositioned in the steering wheel hub.

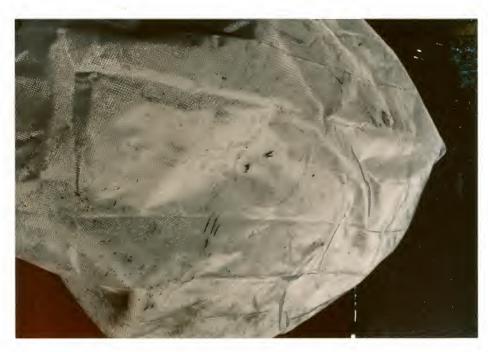
44. View of the nontethered air bag with the 12 o'clock position of the bag oriented at the top of the photograph.

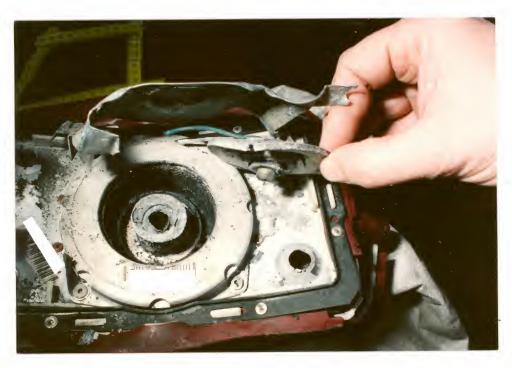
continued, the air bag inflator unit experienced a failure of the igniter weld land. This failure resulted in the bulging of inflator unit and the resulting fracture of the inflator base section (refer to photographs #47, #48 on page A-24).

47. Lateral view of the ignitor squib (Part #1) which was separated from the base of the inflator during the deployment sequence.

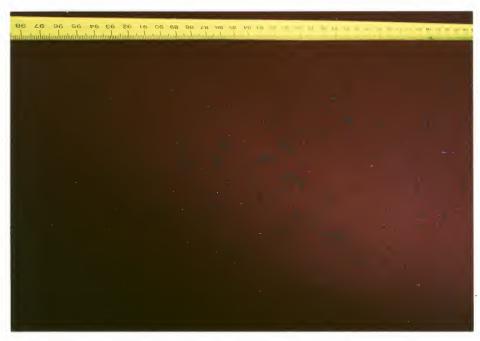
Black burn marks the size of BBs were noted to in the roof liner which began near the windshield header in the center of the vehicle and extended 99 cm (39") rearward into the right rear seat area. The pattern was 22.9 cm (9.0") wide near the windshield header and widened to 30.5 cm (12.0") in the right rear seat area.

51. Close-up view of BB size burn marks from air bag generant debris embedded in roof fabric along the right side.

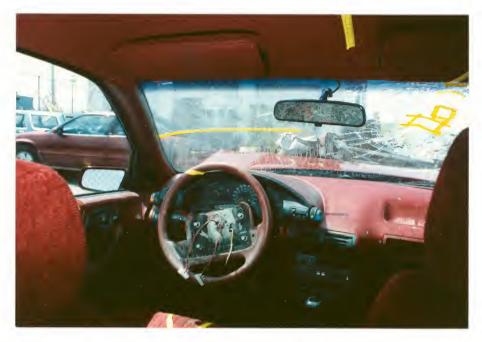
53. View of the driver's side showing generant debris on the windshield and the steering wheel hub without the air bag module.

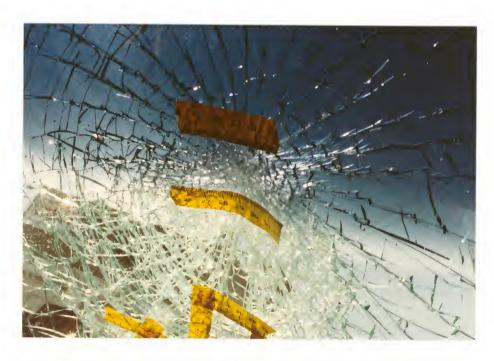
58. Close-up view of right front occupant contact on the windshield.

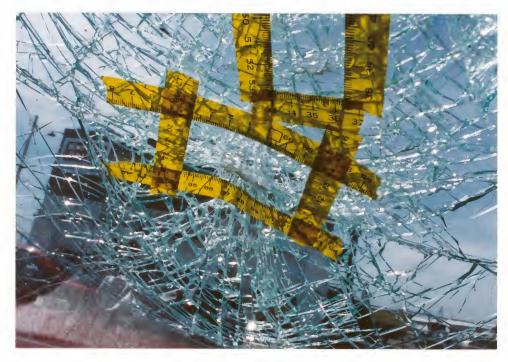
59. Close-up view of mascara and tissue transfer from the right front occupant on the windshield.

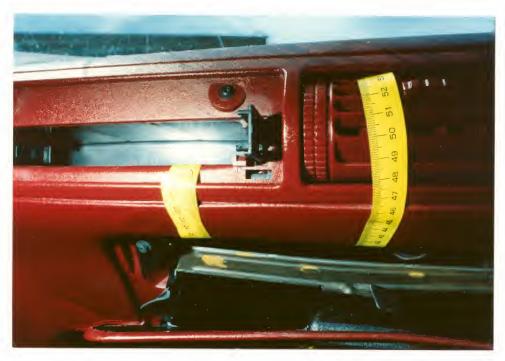
60. Contact evidence from the right front occupant at the mid instrument panel level.

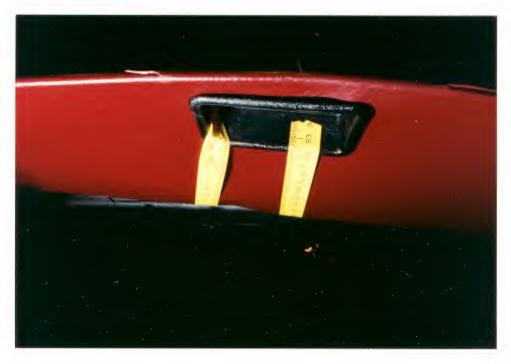
61. Deformation of the glove compartment door from contact by the right front occupant.

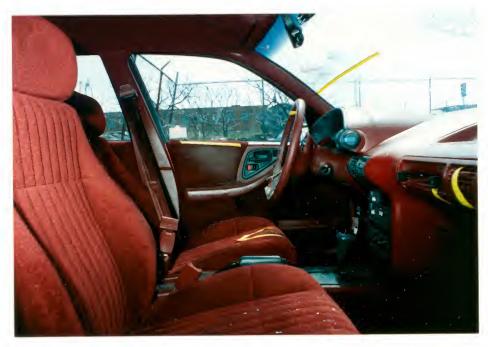
63. View of the driver's door illustrating the singed area above the armrest and melted fabric below the armrest from air bag generant debris.

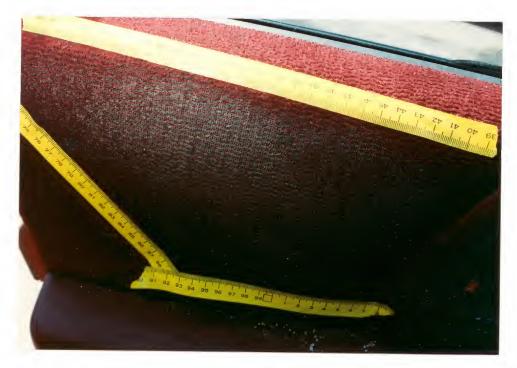
65. Close-up view of the singed fabric above the left front door armrest from air bag exhaust gases.

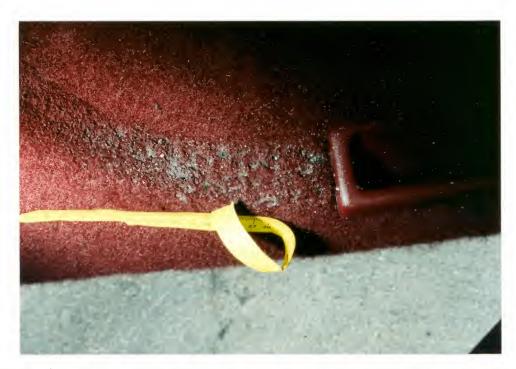
Burn marks in the driver's door side panel below the door arm rest resembled the size of BB shot and were associated with discharged sodium azide pellets (refer to photograph #66 on page A-33). This area was located 10.2 cm (4.0") rear of the instrument panel and extended 15.2 cm (6.0") along the horizontal surface.

66. Close-up view of the melted fabric below the driver's door armrest from air bag generant debris.

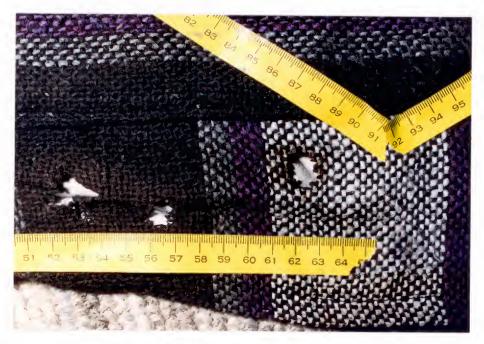
77. Close-up view of the lower portion of the pullover shirt fabric illustrating burn holes from air bag generant debris.

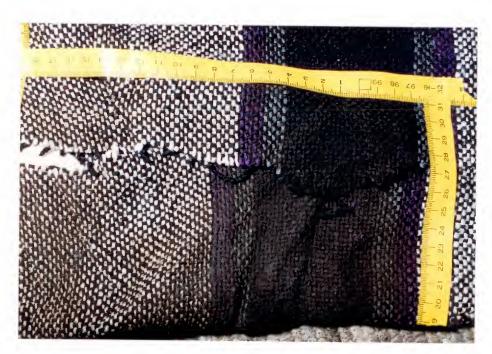
78. Close-up view of the left arm fabric illustrating discoloration from air bag exhaust gases.

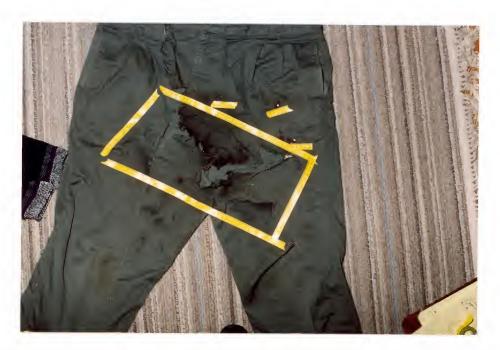
The driver indicated he noticed red embers falling from the steering wheel hub which landed on his lap. An examination of the driver's cotton pants and lower portion of the his pullover shirt revealed several burn holes which several were of BB size. Three large holes were noted above the crouch area in the pants and left of the zipper in which two holes measured 1.3 cm (0.5") in diameter and the third measured 0.48 cm (0.19") in diameter. These holes exhibited a surrounding dark ring burn pattern (refer to photographs #79, #80 on page A-40).

79. View of the driver's pants showing burn holes and heat discoloration of the fabric. Rips in the fabric were the result of on-scene medical rescue procedures.

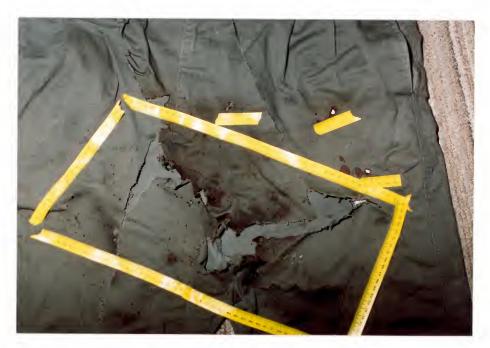
80. Close-up view of burn marks in driver's pants.

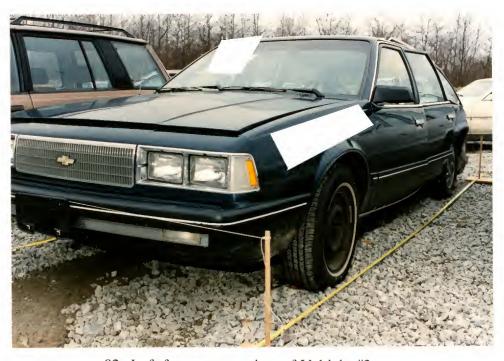
82. Left front corner view of Vehicle #2.

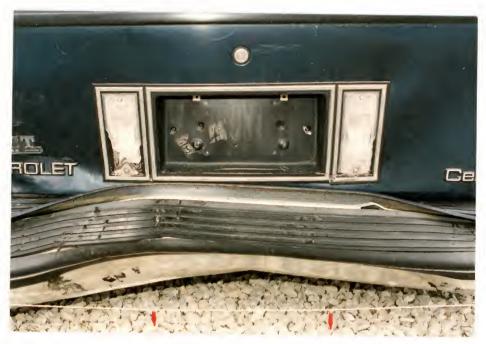
87. View of the center third of the rear plane showing direct contact damage.

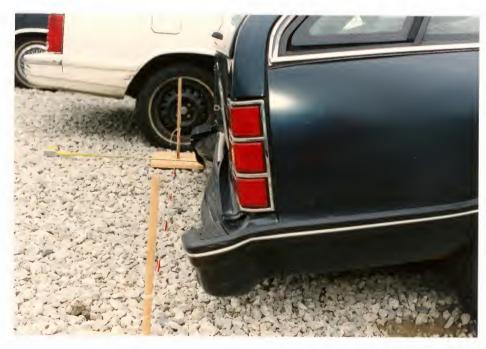
90. Perpendicular view of the right side of Vehicle #2 illustrating the extent of vehicle crush.

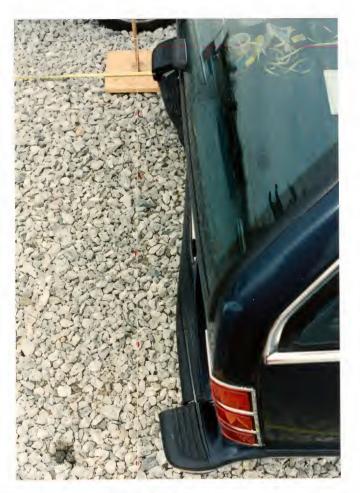
91. Overhead view from the right side of Vehicle #2 illustrating the extent of vehicle crush.

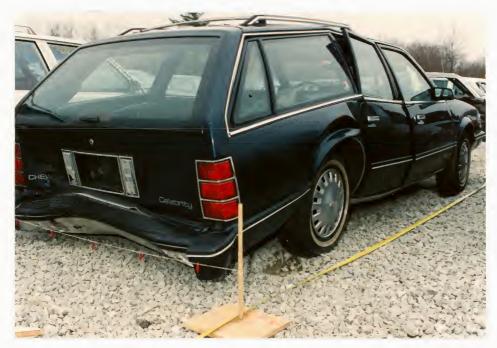
93. Angular view from the right rear corner.

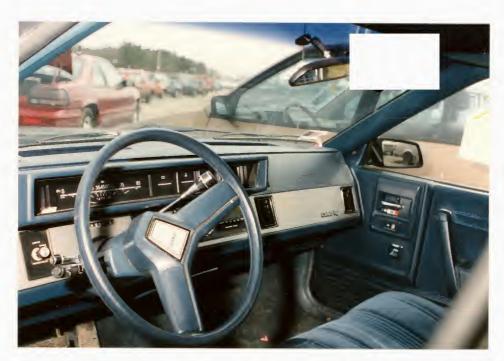
94. View of the instrument panel taken from the left side of Vehicle #2.

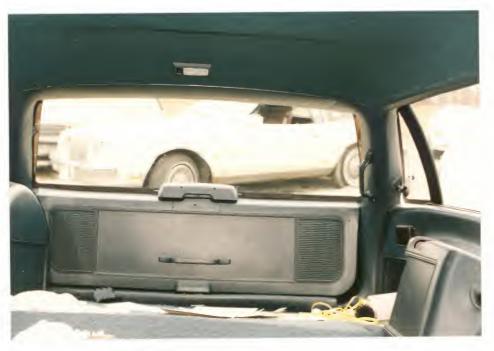
98. View of the rear cargo area.

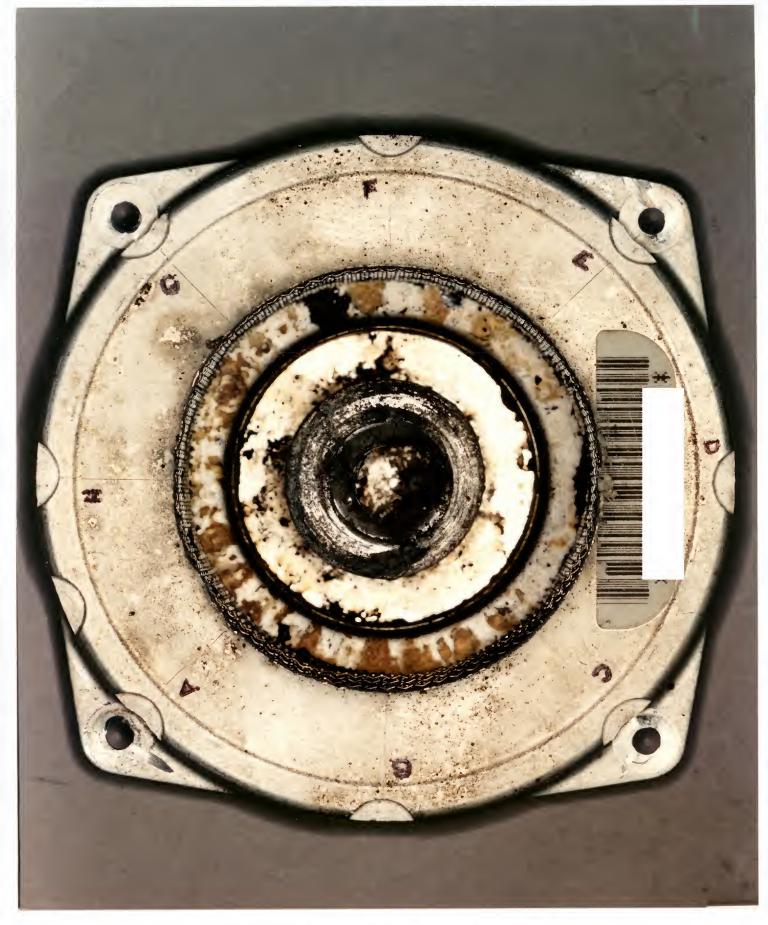
100. Overhead view of the inflator base after cleaning.

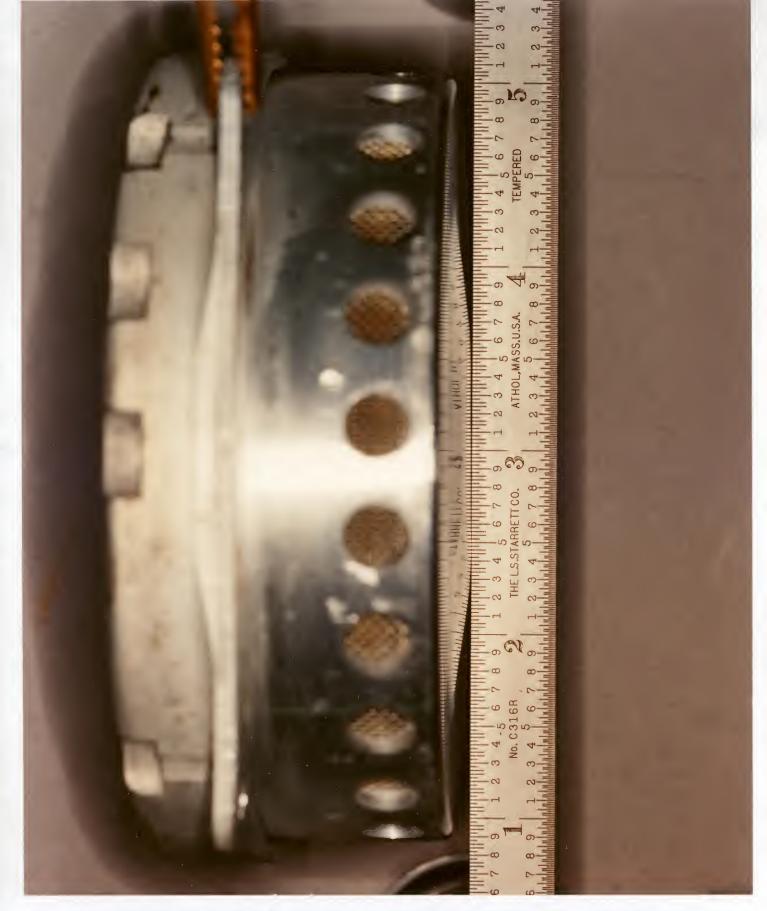
102. Side view of the inflator showing the distortion ("bulge") of the diffuser surface in relationship with a calibrated scale.

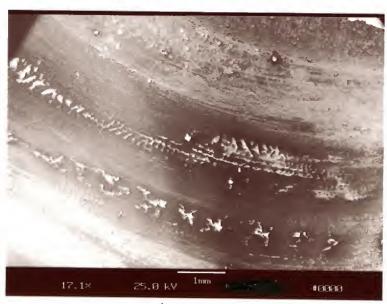
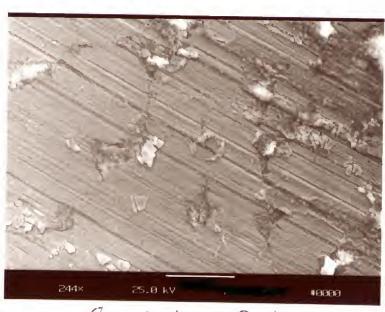
SEM PHOTOGRAPHS Field 3 - Part 1 (Post Cleaning) - Igniter Weld Land Non Fused Area

Non-fused Avea Part /

Non-Fused trea Part 1
